February 29, 2024

Reference Number: 24337

**RE: 121 Cavan Street, Port Hope, ON
Structural Assessment**

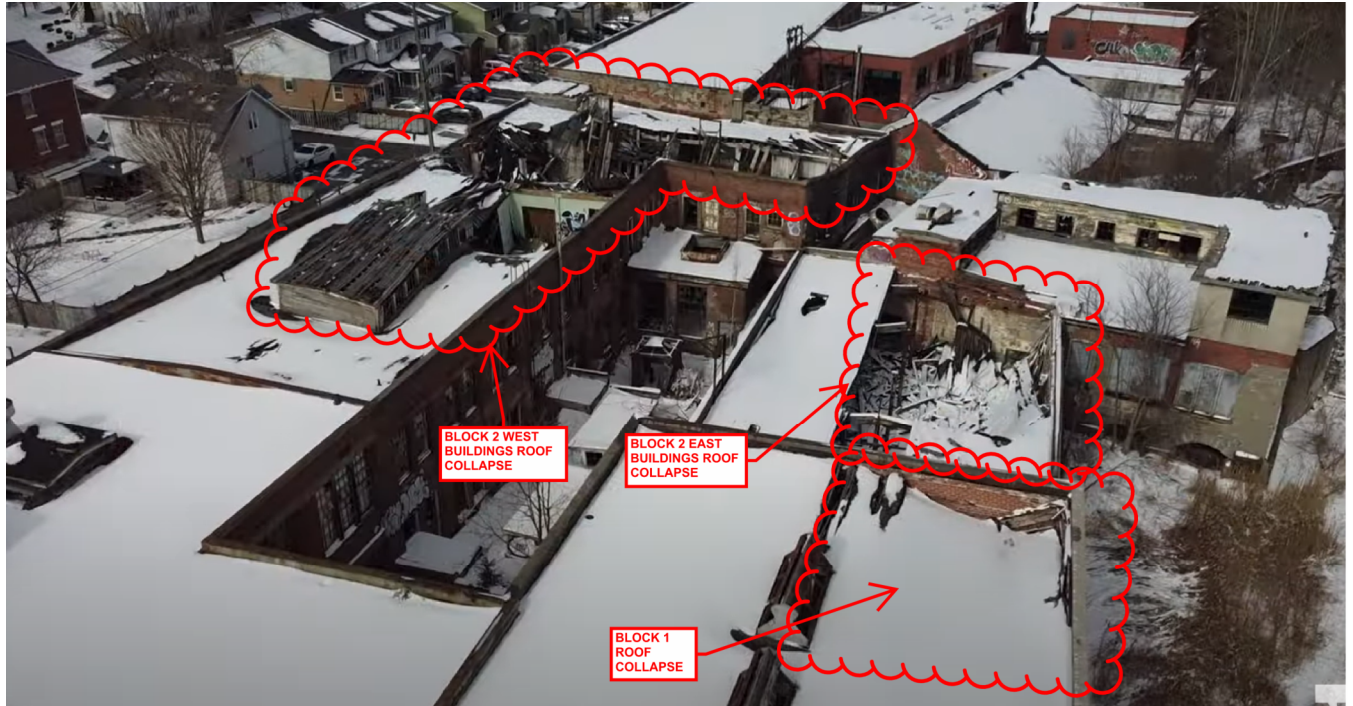
Photo 1: Aerial View – Roof Collapse East Portion Block #1, Large Portion Block #2

Block #2 is constructed of timber framing and flooring for both 2nd floor and roof levels. This block has experienced the most severe damage of the five blocks on the property, including substantial areas of both roof and 2nd floor collapse. The most widespread area of collapse occurs within the region directly behind the exterior west brick wall, where the parapet has begun to fall over and bowing out of the exterior wall was observed. See photo 3 and 4. We were unable to access the eastern buildings within block 2, however from aerial view drone footage substantial roof collapse has occurred here as well. See photo 1. Parapet

Block #2, including the west exterior brick wall and parapet within block #2 impose the immediate safety concern to the public and should be demolished immediately. We recommend demolishing this block in whole and demolishing the west exterior wall up to the south end of block #5 and the north end of block #1. The demising wall between blocks #1 and #2, and between blocks #5 and #2 should remain in place during this demolition as in some areas, these walls are load bearing for the adjacent blocks. Care should be taken to ensure the demising walls are stabilized either by ensuring they are tied into the adjacent floor and roof structures of blocks #1 and #5, or by providing temporary shoring in areas where the walls are not braced by these floor structures.

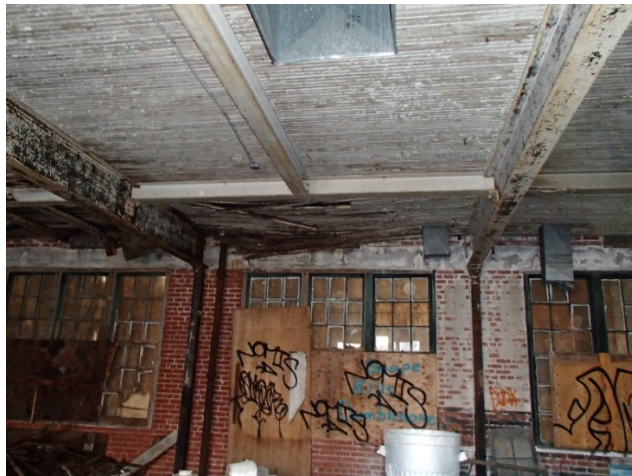
In general, block #1 was observed to be constructed of structural steel with mill deck floor on the 2nd floor. The perimeter beams appear to be structural steel encased in concrete. We were unable to access the 2nd floor level in order to observe the roof, however from aerial view drone footage it can be seen that the east portion of the roof has collapsed, see photo 1. Structural damage observed on the walk-through included failed 2nd floor deck/collapse, see photos 2a and 2b. The 2nd floor structural steel framing and west exterior brick wall have experienced some weathering; however, do not appear to show signs of significant deterioration in areas we were able to observe.

Photo 2a: 2nd Floor Deck Collapse in Block #1

Block #1 should be the next block demolished following block #2. Although the west exterior wall within this block appears to be in reasonable condition, there were areas of floor and roof collapse observed within this block. Following the demolition of block #1 we recommend demolition of block #3, and finally block #5. Block #3 and #5 demolition can occur at a later time as block #3 does not front Cavan Street, and block #5 has not shown any sign of collapse at this time within the portion of building directly fronting Cavan Street.

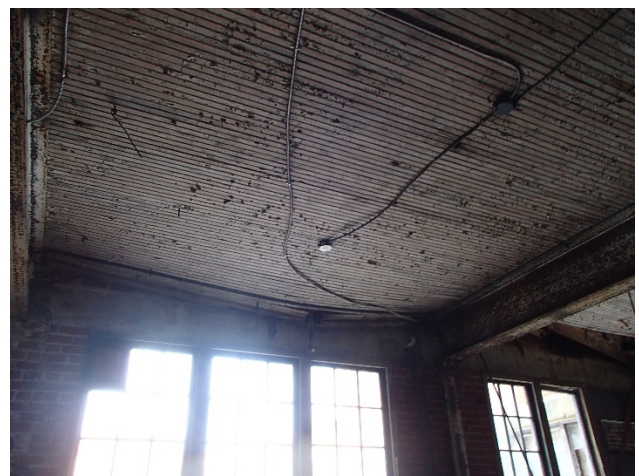
Photo 2b: 2nd Floor Deck Collapse in Block #1

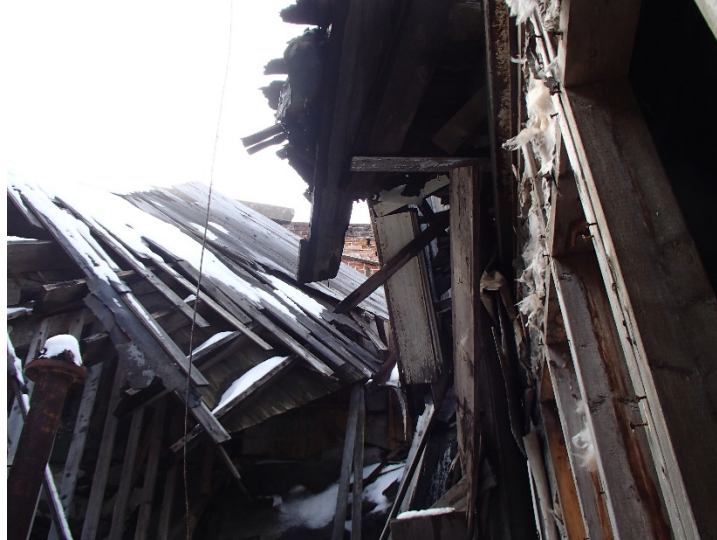
Photo 3: 2nd Floor and Roof Collapse, Block #2, Area behind West Exterior Wall

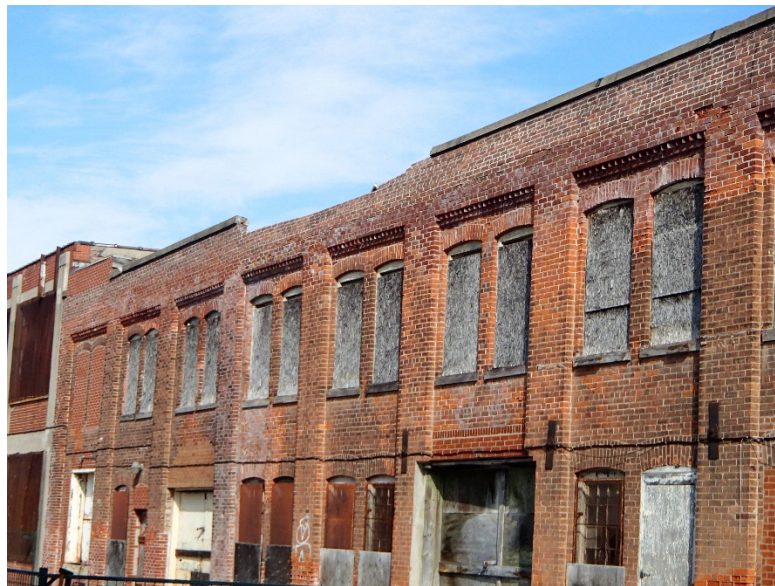
Photo 4: Parapet Deterioration and Wall Bowing, West Wall, Block #2

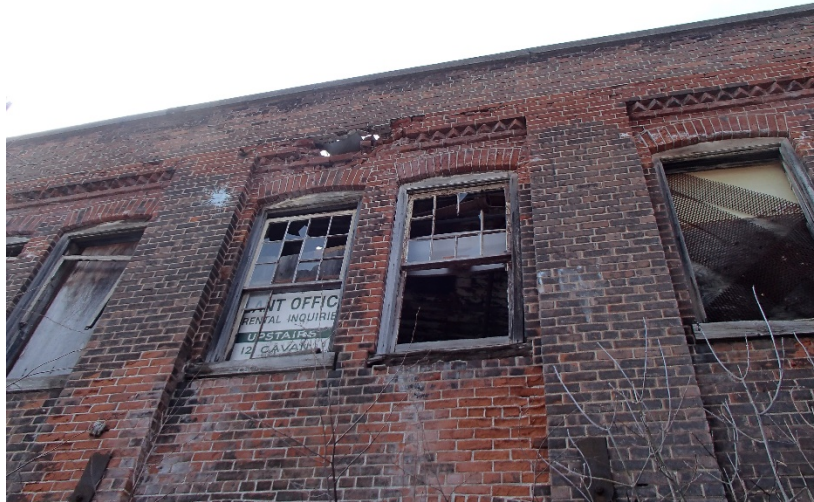
damage was also observed on the east side of the west building. See Photo 5. In other parts of the building where collapse has not occurred, the bottom 2'-3' of timber columns appear to have experienced water damage/surface rotting.

Photo 5: Parapet Deterioration East Wall, Block #2

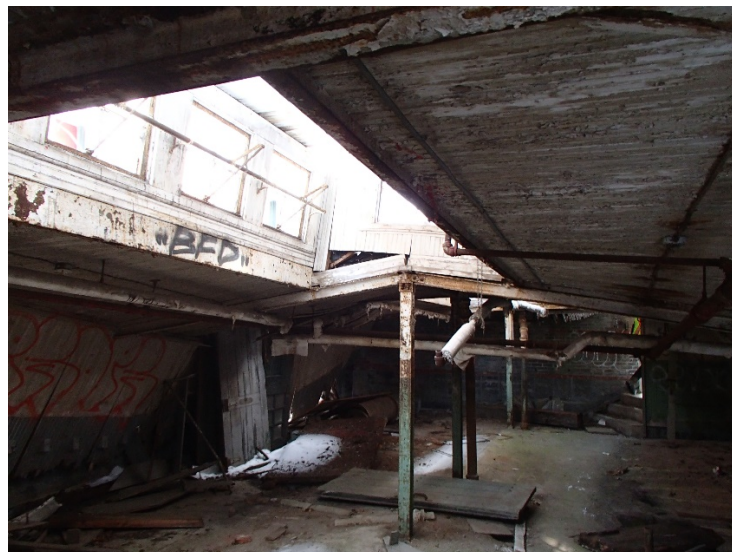
Block #3 is located away from the Cavan Street frontage. Buildings within this block consist of a mix of structural steel and mill deck, as well as timber framed buildings. The greatest structural damage within this block occurs in the courtyard area where a structural steel building has experienced collapse. See photo 6. In some of the timber framed areas, temporary steel shore posts were observed.

Photo 6: Collapse in Courtyard Area Building, Block #3

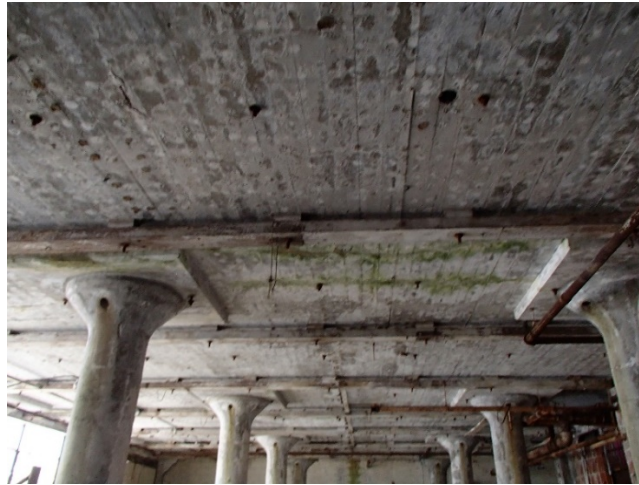
Block #5 consists of reinforced concrete beams, columns, and floor for the ground and 2nd floor levels. What appears to be numerous anchors through the concrete floor, drop panels, and column capitals were also observed. It is unclear what the purpose of these anchors were used for. See photo 7. The upper level/roof consists of structural steel columns with what appears to be modern construction of timber roof with wood beams and joists. See photo 8. Even though block #5 appears to be in better condition, there is still substantial deterioration at the 2nd floor finished floor level where water egress and rotting floor boards were observed. From our observations the floor boards are a floor finish and are supported on the concrete floor.

Photo 7: Ground Floor Level Looking up at Underside of 2nd Floor – Block #5

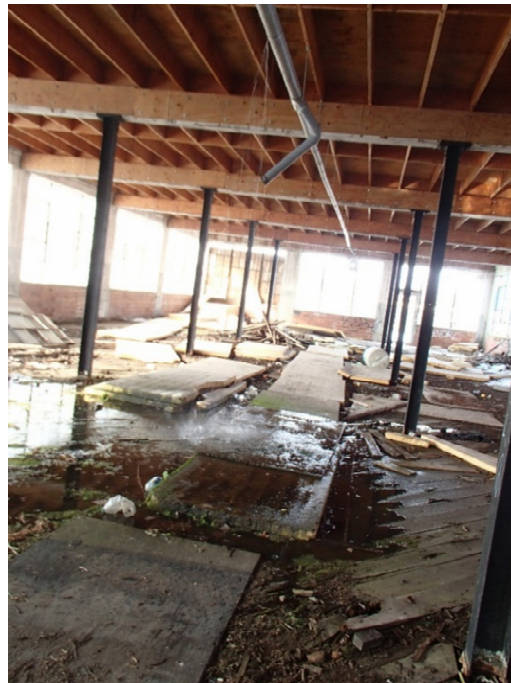
Photo 8: 2nd Floor Level Looking up at Underside of Roof, Roof Drain Pouring into Building – Block #5
