# Port Hope File Factory

A plea for taking more care

121 Cavan St., The File Factory, Port Hope

17 July 2020

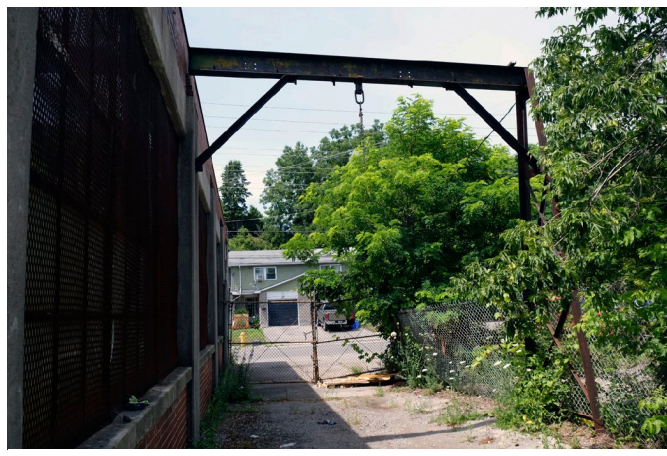
Exterior steel hoist structure, preserve on site

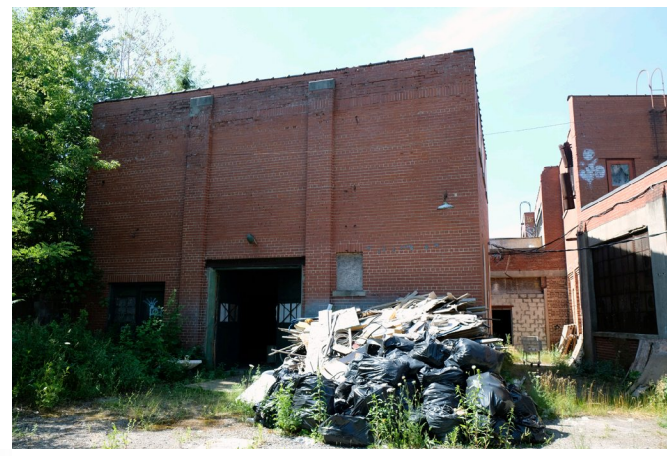
1935, encourage reuse of structure, could be altered to suite new purpose

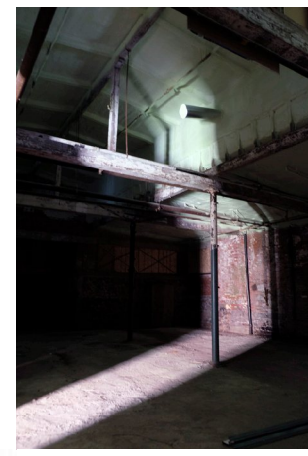
1919 building, east elevation overlooking river is significant public facade, encourage reuse of some or all of remainder

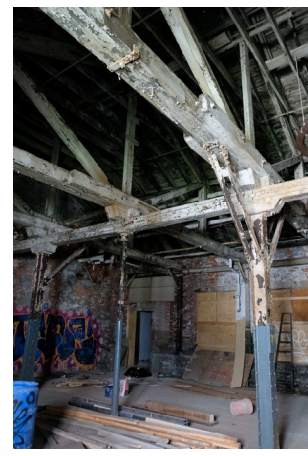
1889 building, east elevation and roof form overlooking river is significant public facade, encourage reuse of some or all of remainder

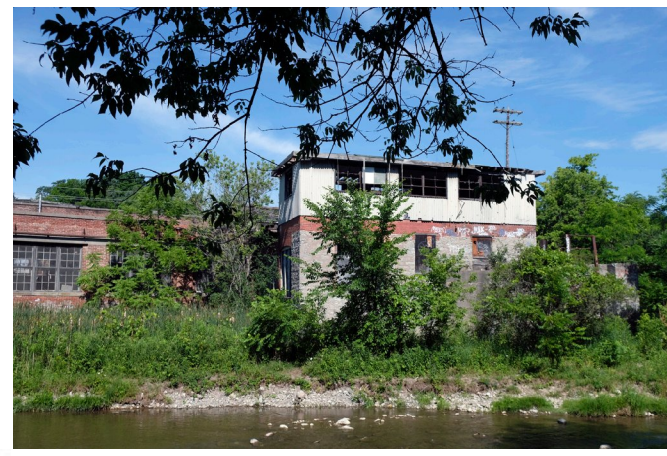
1850-1889, East elevation overlooking river, ground floor stone and brick walls incorporating part walls from original 1850s mill, window openings with multi lite windows, side wall returns to buildings 2 and 4. (encourage preservation of associated mill race and remnant dam structures and interior wood heavy timber structure, remand of 1850s mill)

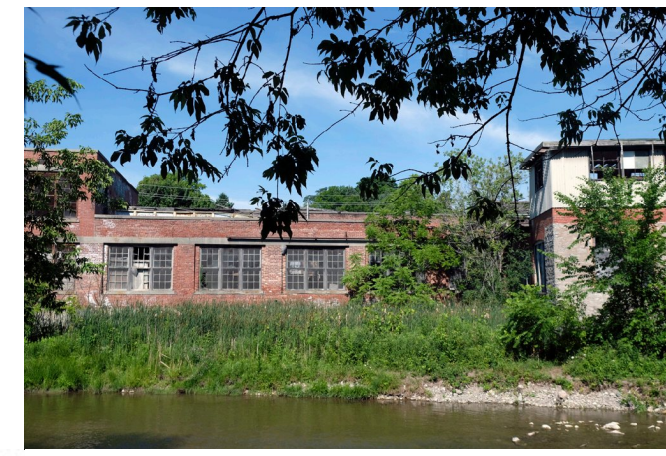
1902, East elevation overlooking river, 1 storey brick walls with concrete banding and wall cap, expressed pilasters, 6 part multi lite windows in 5 window bays with concrete lintels and sills

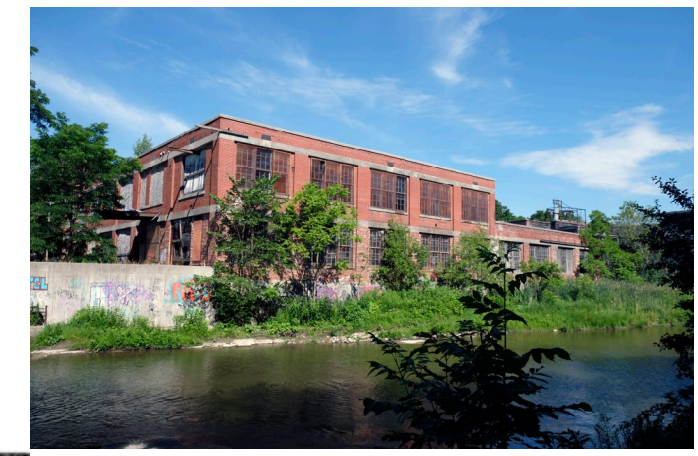
1902, East elevation overlooking river, 2 storey brick walls with concrete banding and wall cap, expressed pilasters, 6 part multi lite windows in 5 window bays with concrete lintels and sills

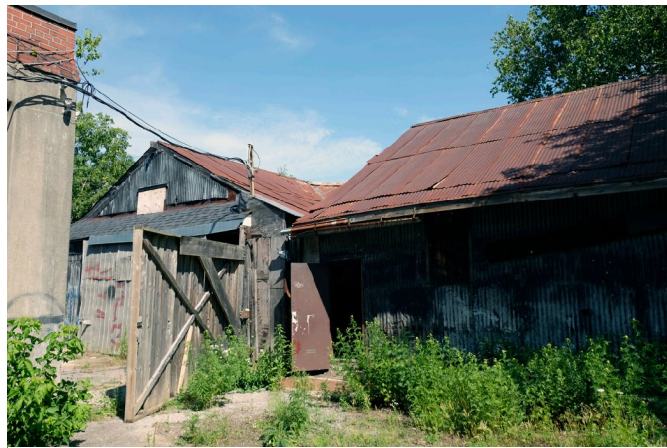
1935, (10, 11) 1 storey roughly constructed shed structures not significant, some previously demolished (18,19, 20, 21, 14, 22, 28, 12)

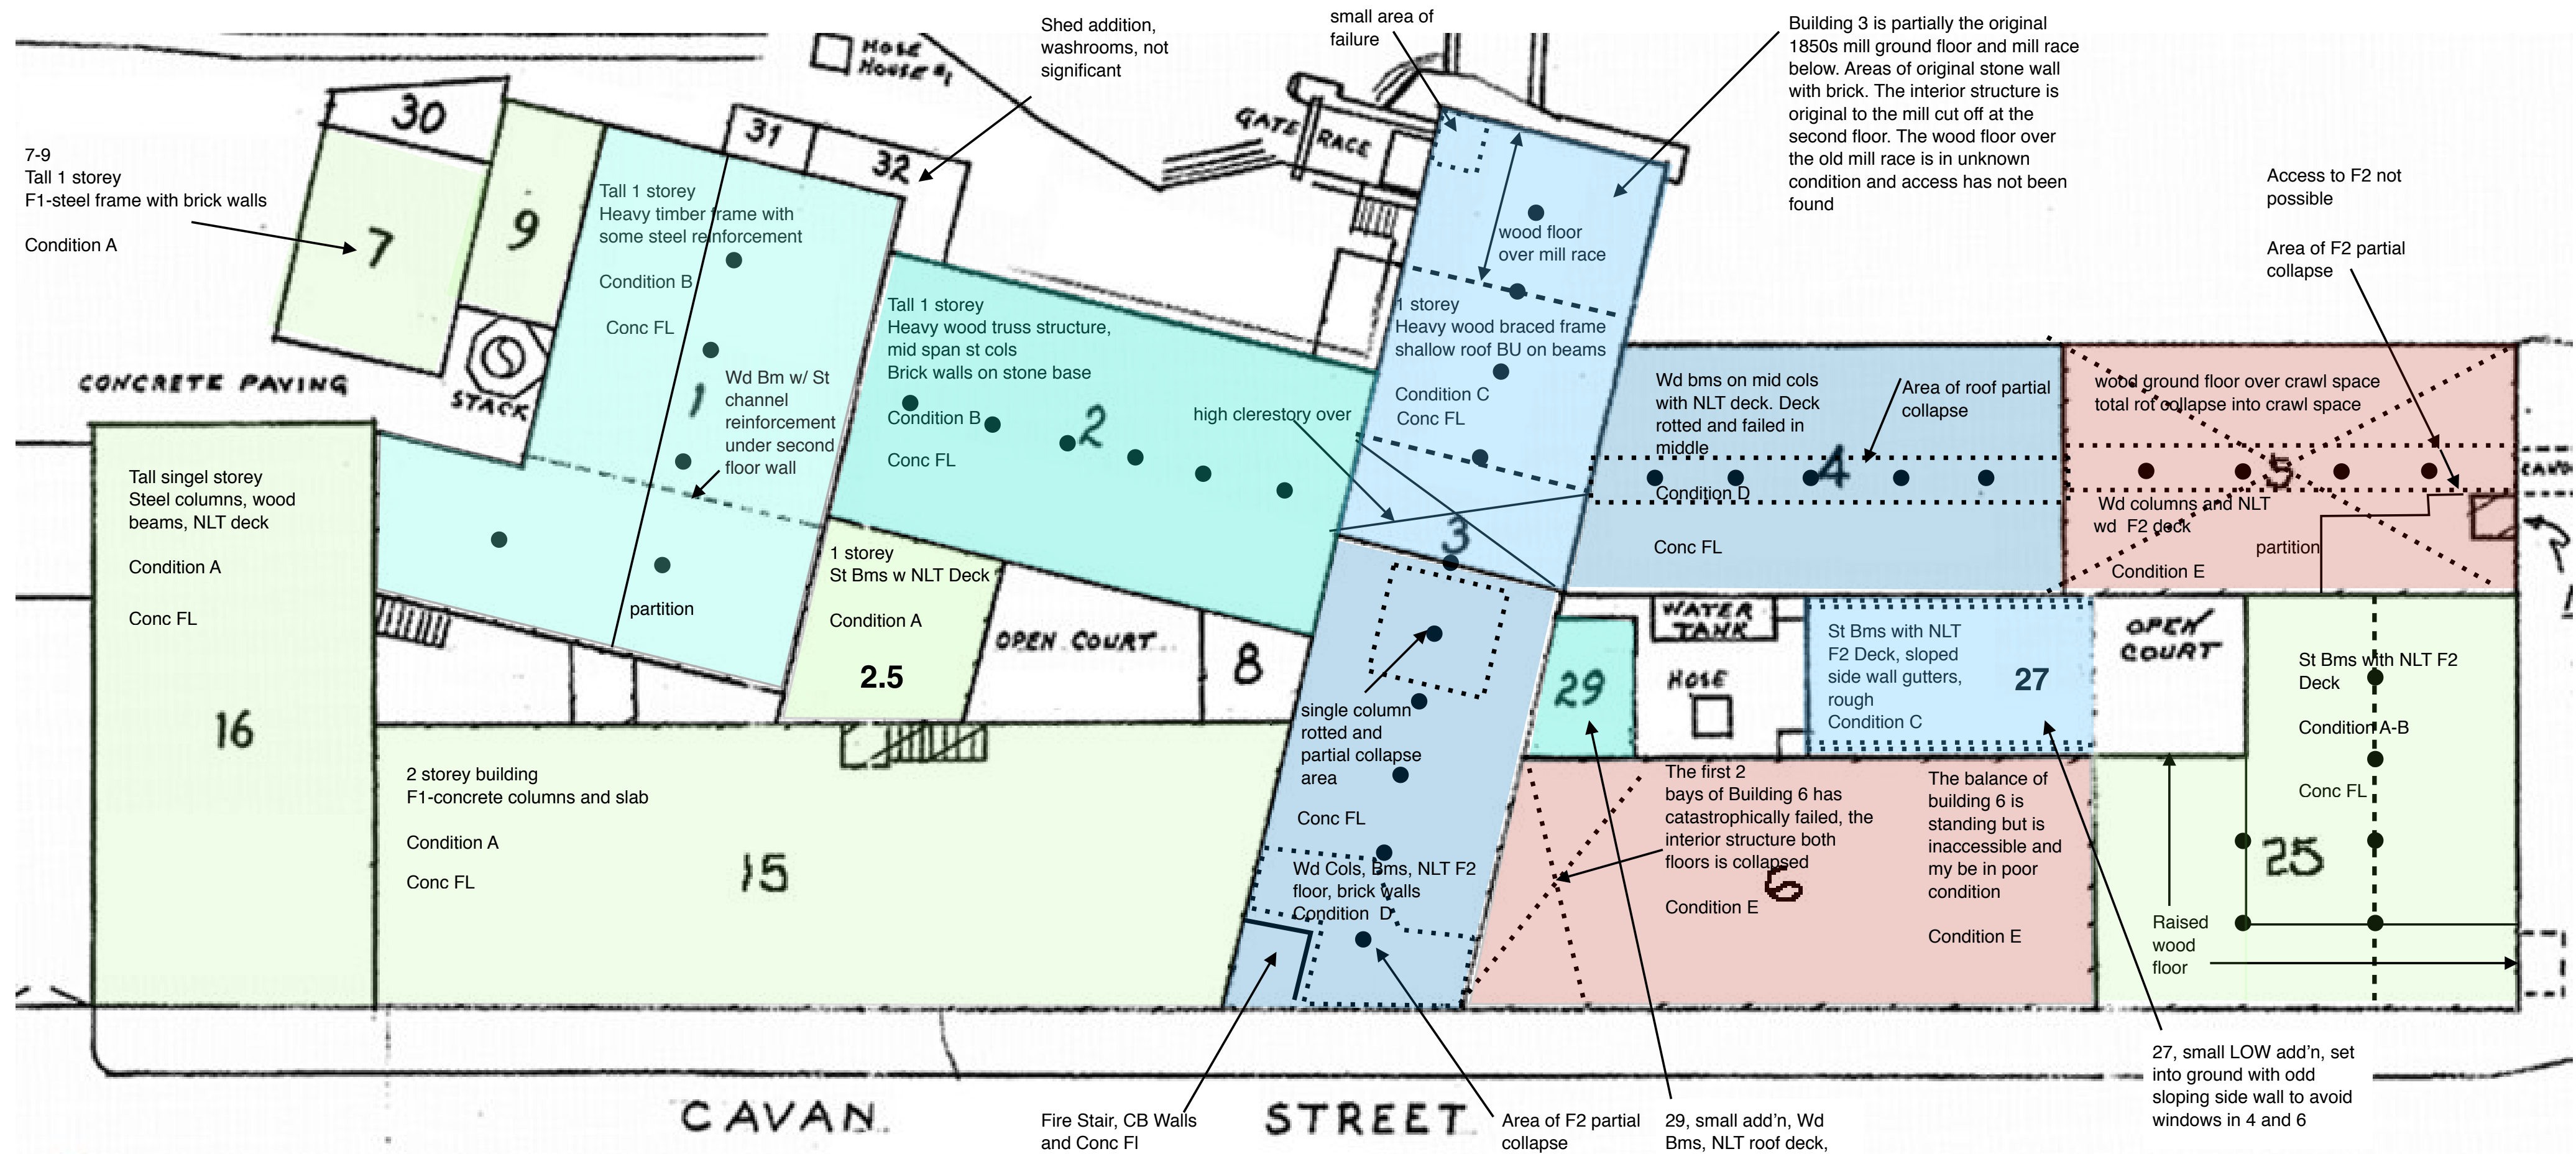
**Condition Overview - F1**

- A - Requiring some modest repairs, reusable, generally good
- B - Requires repair to walls and structure, fully standing, reusable
- C - Requires structural repairs, small local failures, walls require repair, reusable
- D - Requires structural replacement, mostly standing with failed areas, walls require repair reusable walls
- E - Requires structural replacement, total internal structural failure-collapse, walls require repair, possible reusable walls

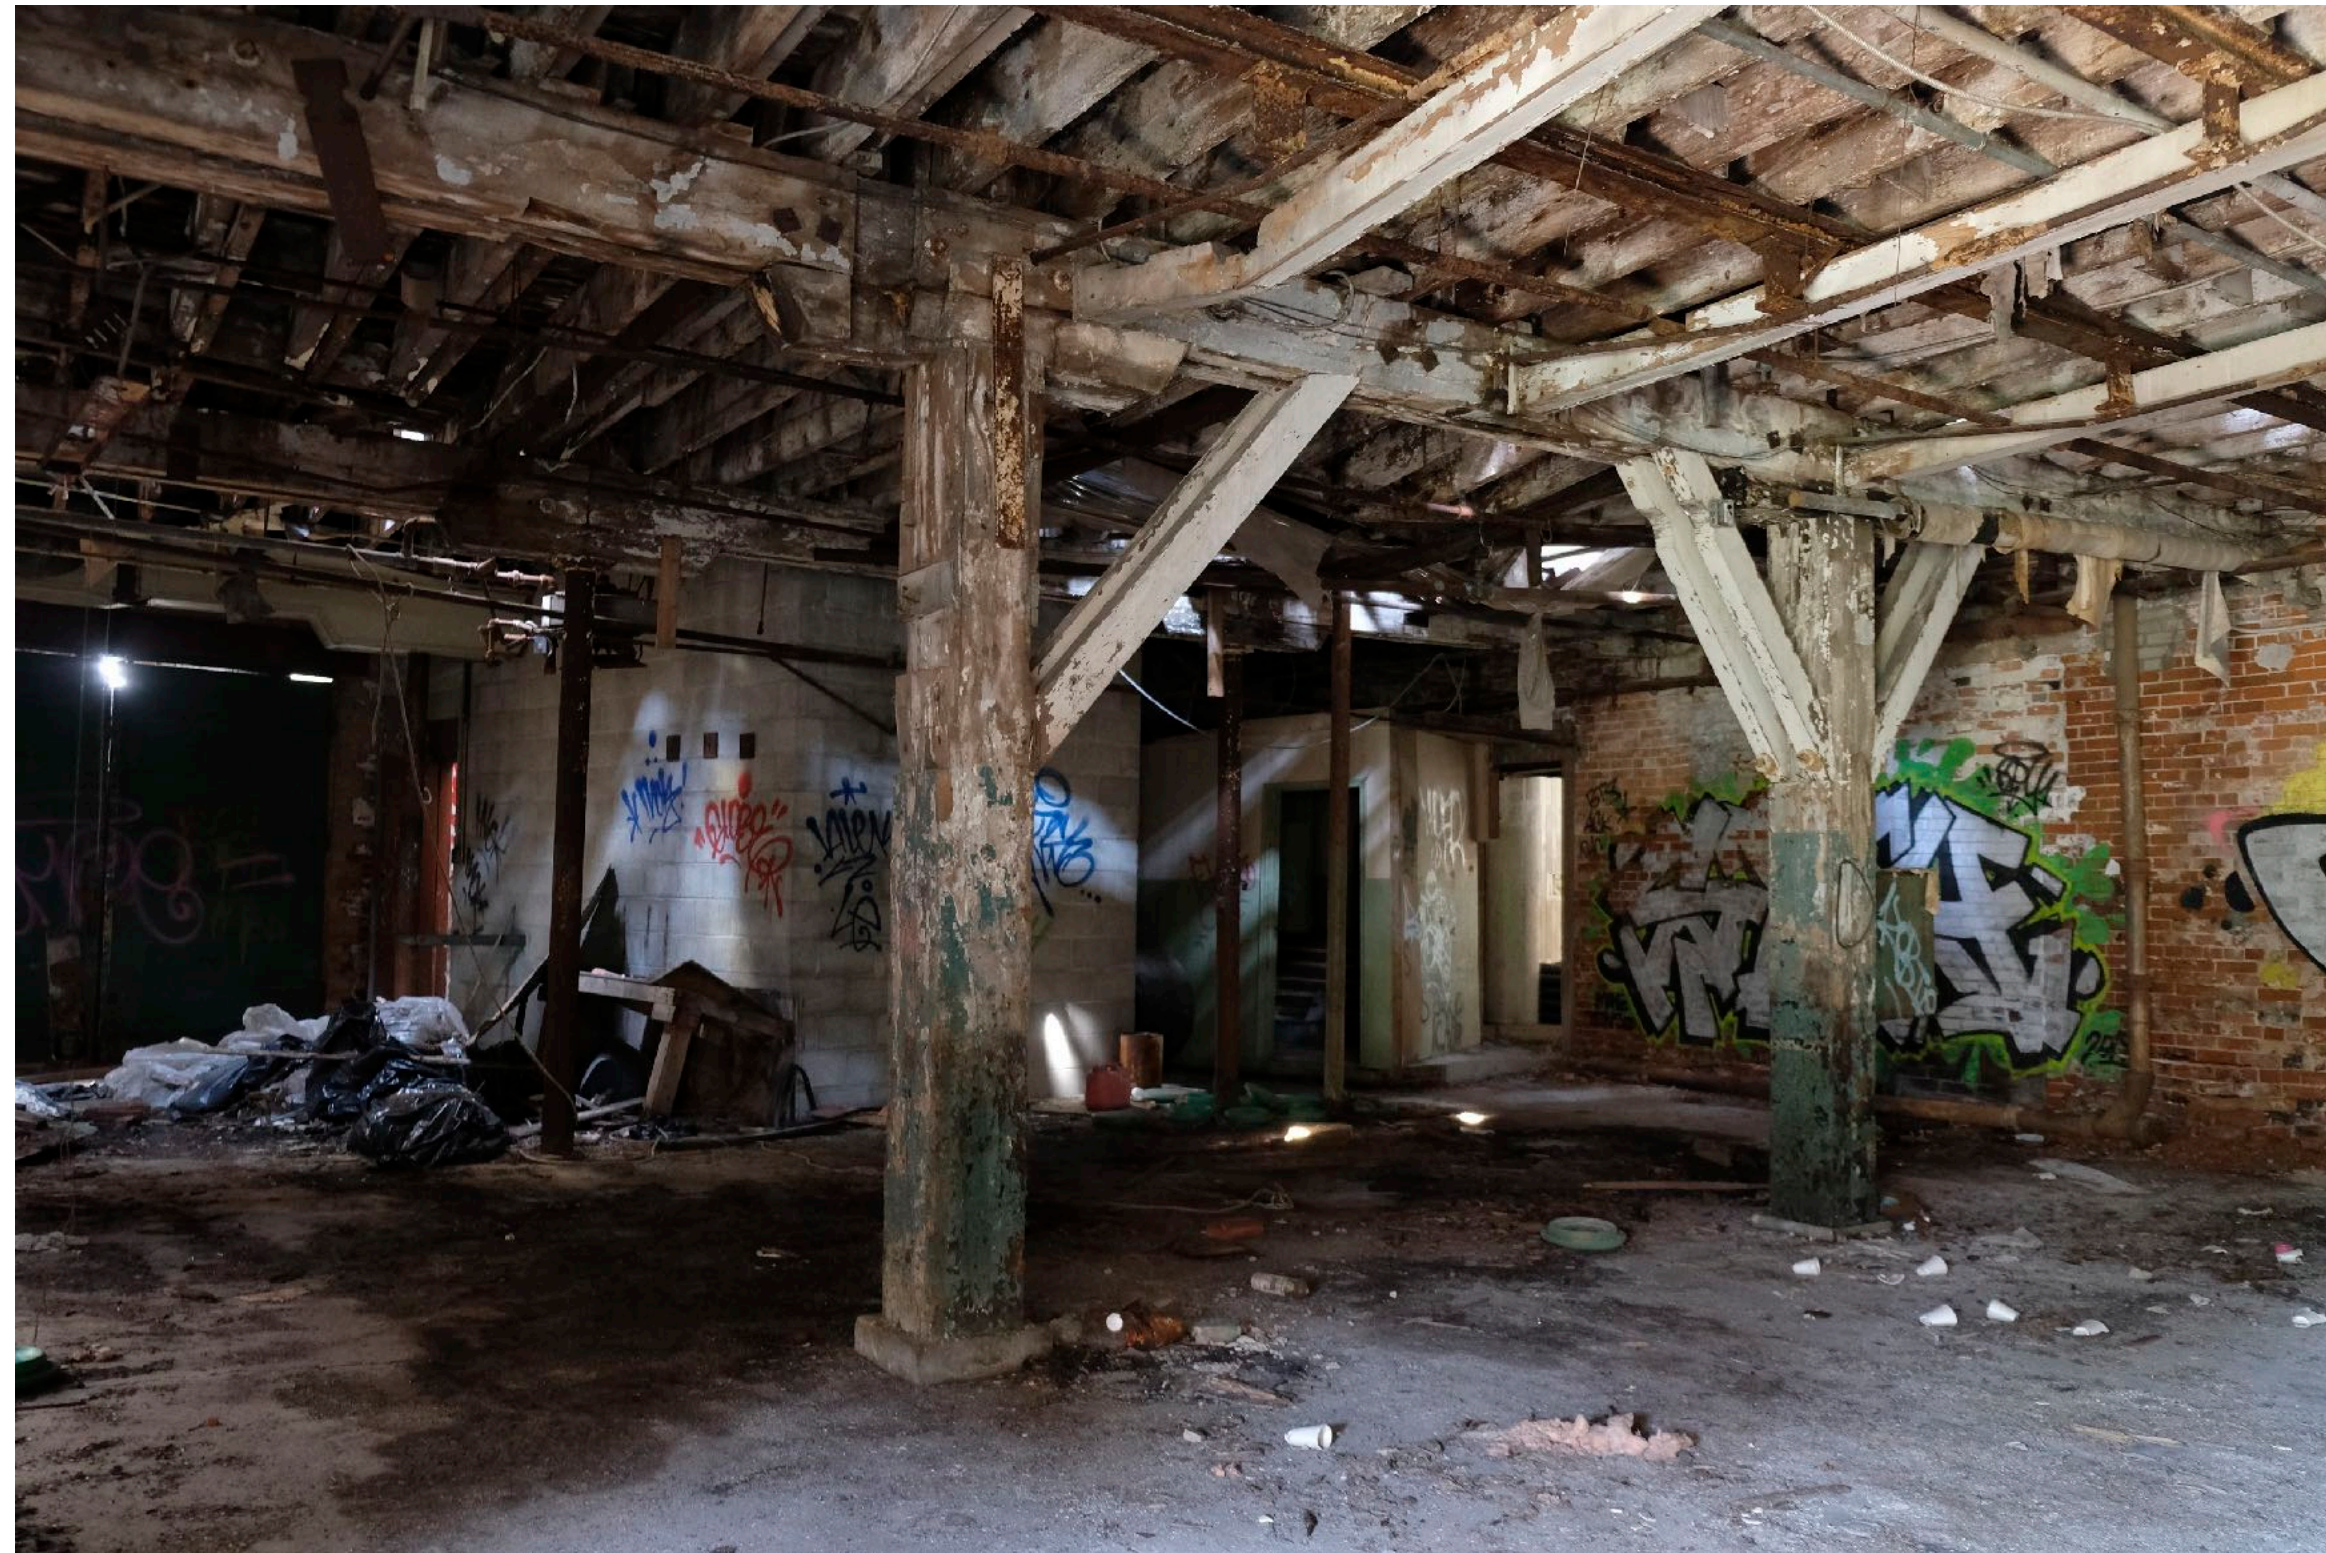
The interior of building 3, the Beamish mill area. The structure is mass stone masonry exterior walls with a heavy timber frame and wood second floor. Rotted wood needs to be removed while the primary frame could be retained, reinforced and jacks added and braced as part of a retention strategy.

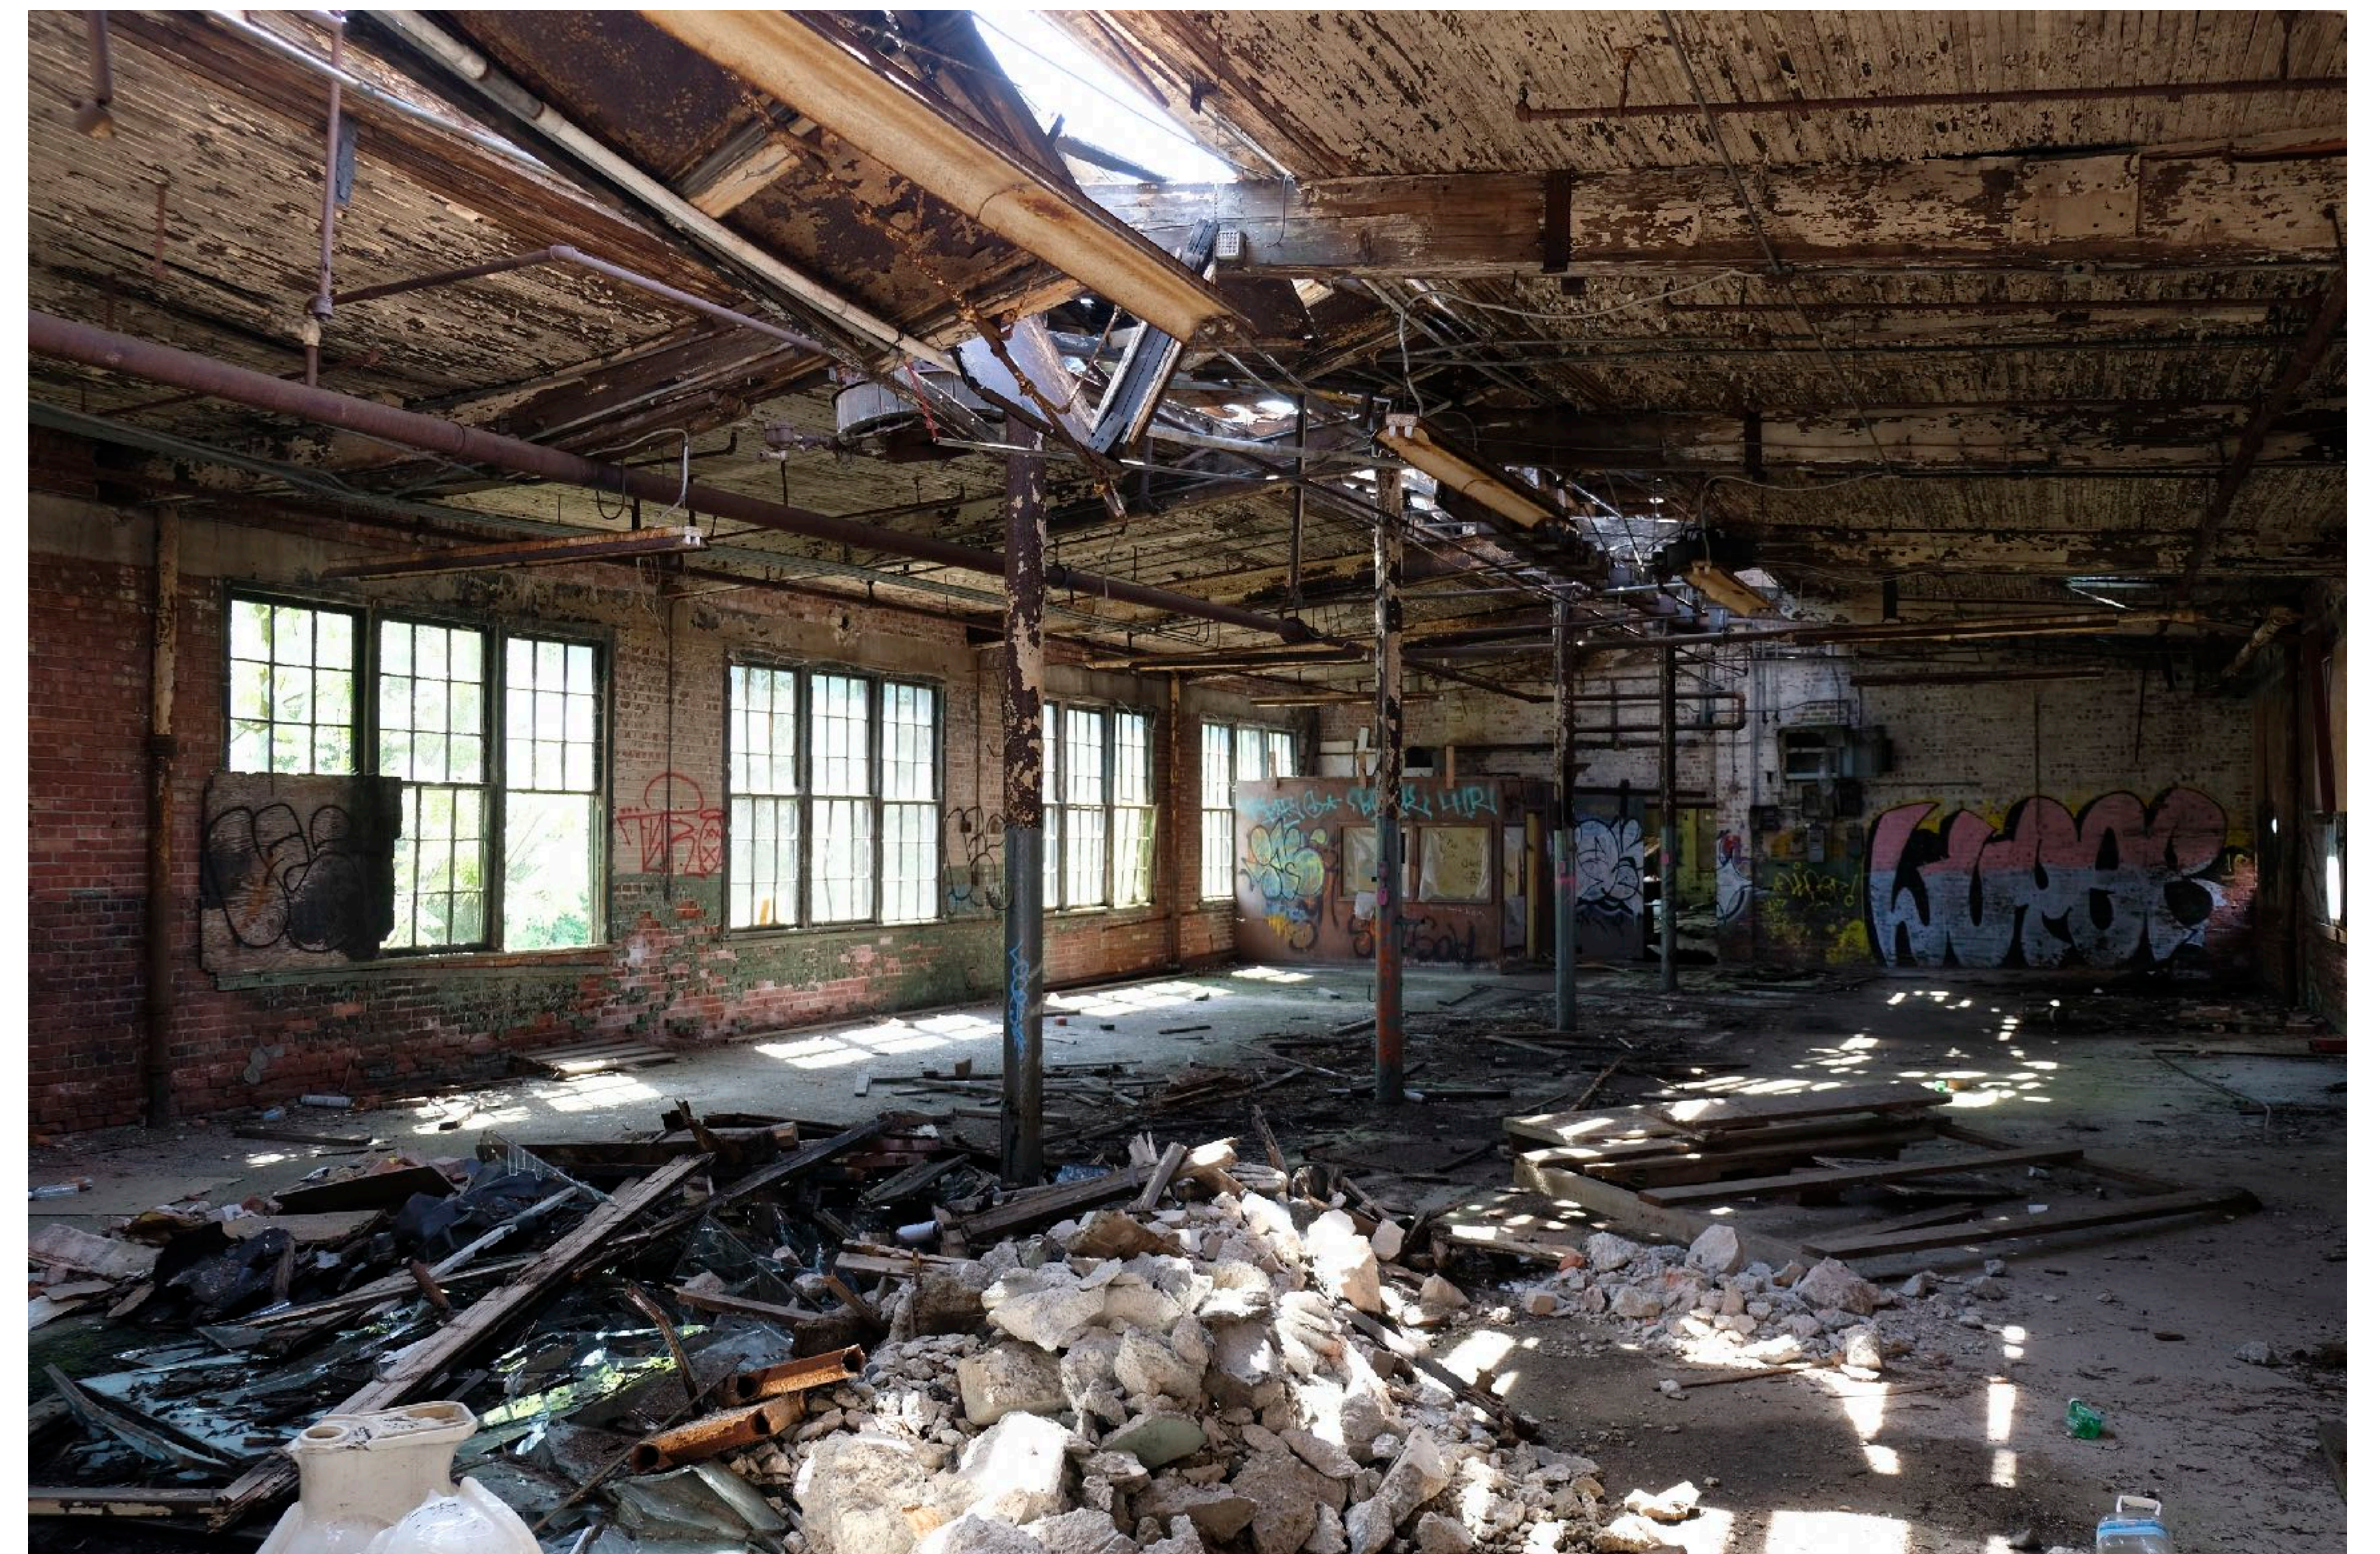
The interior of building 4. The structure is mass masonry exterior walls with a primary steel frame and wood second floor. The wood needs to be removed while the steel could be retained and braced as part of a retention strategy.
