February 29, 2024

Reference Number: 24337

**RE: 121 Cavan Street, Port Hope, ON
Structural Assessment**

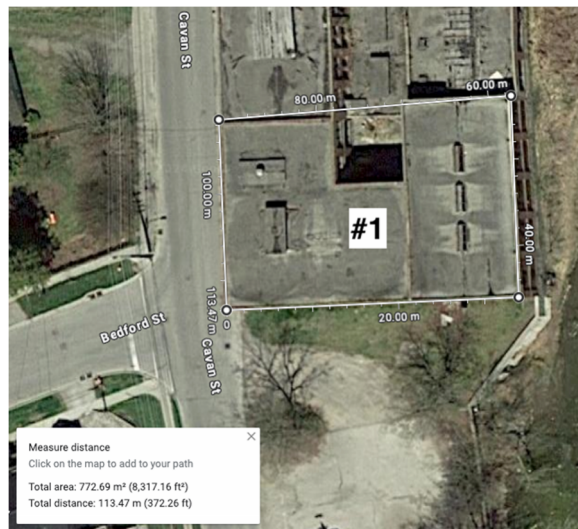
Figure 1: Block #1 – Southern Block

In general, block #1 was observed to be constructed of structural steel with mill deck floor on the 2nd floor. The perimeter beams appear to be structural steel encased in concrete. We were unable to access the 2nd floor level in order to observe the roof, however from aerial view drone footage it can be seen that the east portion of the roof has collapsed, see photo 1. Structural damage observed on the walk-through included failed 2nd floor deck/collapse, see photos 2a and 2b. The 2nd floor structural steel framing and west exterior brick wall have experienced some weathering; however, do not appear to show signs of significant deterioration in areas we were able to observe.

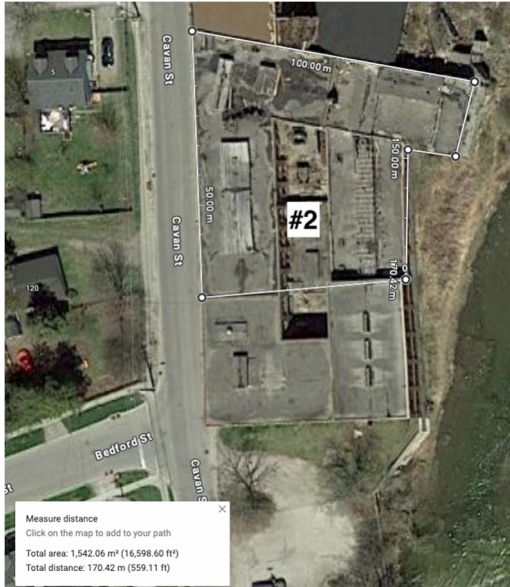
Figure 2: Block #2 – Middle Block

Block #2 is constructed of timber framing and flooring for both 2nd floor and roof levels. This block has experienced the most severe damage of the five blocks on the property, including substantial areas of both roof and 2nd floor collapse. The most widespread area of collapse occurs within the region directly behind the exterior west brick wall, where the parapet has begun to fall over and bowing out of the exterior wall was observed. See photo 3 and 4. We were unable to access the eastern buildings within block 2, however from aerial view drone footage substantial roof collapse has occurred here as well. See photo 1. Parapet

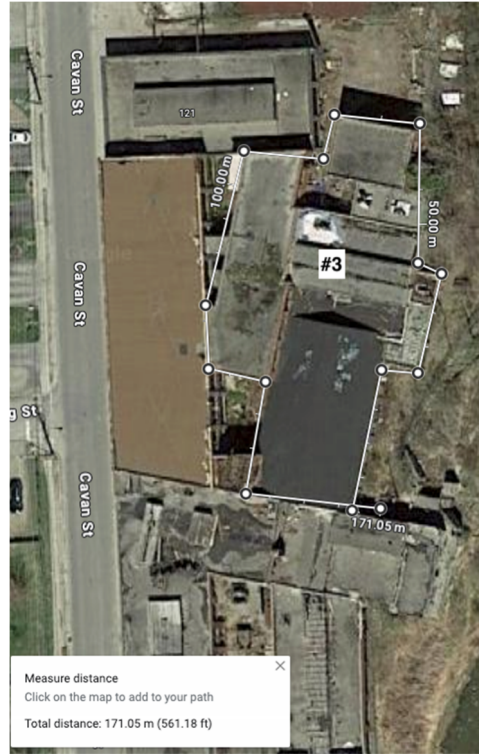
Figure 3: Block #3 – Eastern Block

Block #3 is located away from the Cavan Street frontage. Buildings within this block consist of a mix of structural steel and mill deck, as well as timber framed buildings. The greatest structural damage within this block occurs in the courtyard area where a structural steel building has experienced collapse. See photo 6. In some of the timber framed areas, temporary steel shore posts were observed.

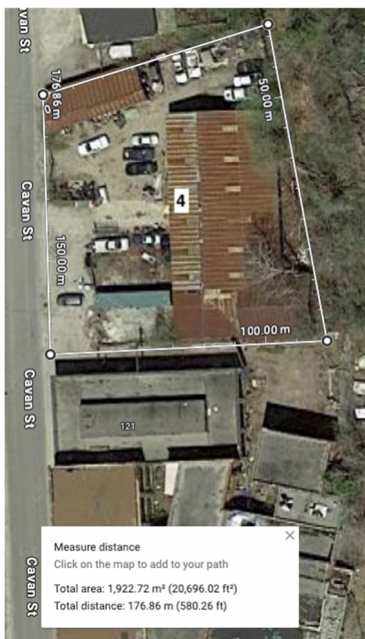
Figure 4: Block #4 – North Stand-Alone Block

Block #4 and the single-story portion of block #5 were not reviewed. Our review was limited to the exterior façade facing Cavan Street, the south exterior façade, and ground floor level where accessible. For block #5 two storey portion, we were also able to access the 2nd floor level. See figures 1 to 5 for a breakdown of the five blocks defined.

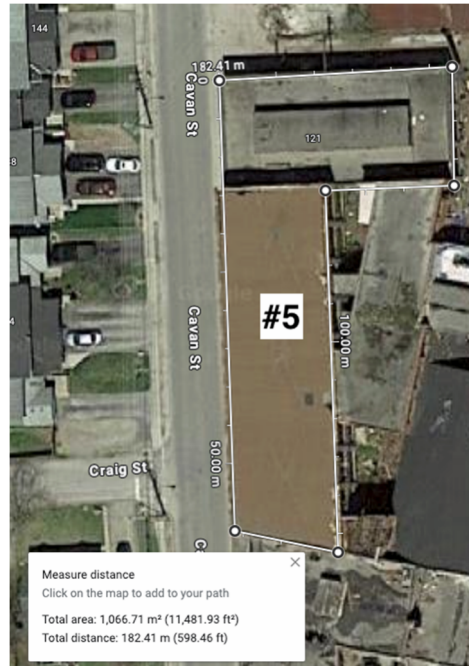
Figure 5: Block #5 – North Interconnected Block

Block #5 consists of reinforced concrete beams, columns, and floor for the ground and 2nd floor levels. What appears to be numerous anchors through the concrete floor, drop panels, and column capitals were also observed. It is unclear what the purpose of these anchors were used for. See photo 7. The upper level/roof consists of structural steel columns with what appears to be modern construction of timber roof with wood beams and joists. See photo 8. Even though block #5 appears to be in better condition, there is still substantial deterioration at the 2nd floor finished floor level where water egress and rotting floor boards were observed. From our observations the floor boards are a floor finish and are supported on the concrete floor.
